RESEARCH MEMORANDUM

TURBOJET ENGINE INVESTIGATION OF EFFECT OF THERMAL

SHOCK INDUCED BY EXTERNAL WATER-SPRAY

COOLING ON TURBINE BLADES OF FIVE

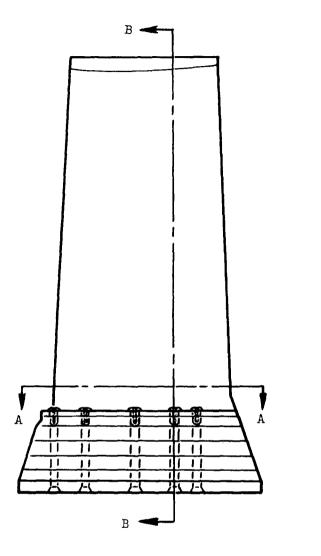
Figure 1. - Turbine rotor blade modified for water injection.

Fifty unmodified production blades of S-816 material and four test blades comprised the complete turbine rotor and blade assembly. The four test blades were of the same profile as the production blades and were modified to include five water-injection orifices in the base as shown in figure 1. The injection orifices were 0.031 inch in diameter and were located along the suction surface. Test blades of two alloys (two of one alloy and two of another) were always installed for any period of cyclic operation. Test blades were made of five high-temperature alloys. The alloys investigated were wrought S-816, Nimonic 80, Inconel X, cast HS-21, and cast Guy alloy. The first four alloys were chosen because they are commonly used in aircraft turbine blades and the thermal-shock effect of spray cooling on such blades should be known in order to evaluate aircraft application of turbine spray cooling. Guy alloy, although not commonly used, shows promise for high-temperature, high-stress applications and was therefore included.

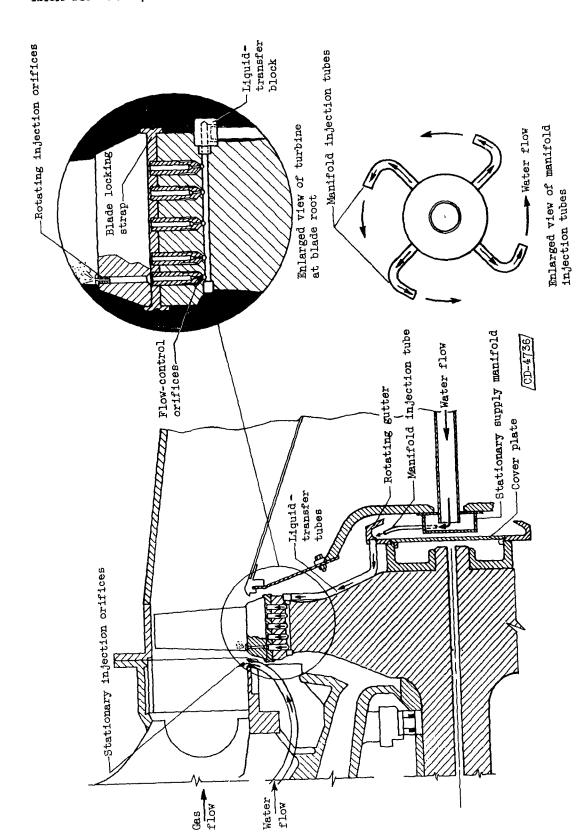
Figure 2. - Sectional view of engine showing ducts for water-spray injection from orifices located in turbine rotor blade bases and from stationary orifices in stator disphragm.

Rotating injection system. - The rotating injection configuration employed in this investigation was one that provided nearly uniform cooling of the blade when used in conjunction with the proper stationary injection configuration (ref. 4). Various components of the rotating injection system are illustrated in figure 2 and the design details are described in reference 4. The four test blades provided with injection orifices in the blade base were spaced at approximately 90° intervals around the rim of the turbine disk. Water was supplied to a stationary manifold (fig. 2) through stainless steel tubing and discharged to the rotating gutter on the rear face of the rotor. The water then flowed radially through four liquid-transfer tubes, which were fastened to the rotor rear face, and into axial passages in the rotor rim directly beneath each of the test blades. The maximum water flow rate for any rotative speed was established by the metering action of 0.015-inch-diameter flowcontrol orifices located in plugs force-fitted into the rotor above the rotor axial passages. Centrifugal force on the water permitted it to bridge the slight clearance space between the rotor and blades. Water then flowed throw; h the drilled passages in the rotor blade base and onto the blade surface through the injection orifices. In order to minimize the possibility of clogging the small flow-control orifices, distilled water was used in the rotating injection system.

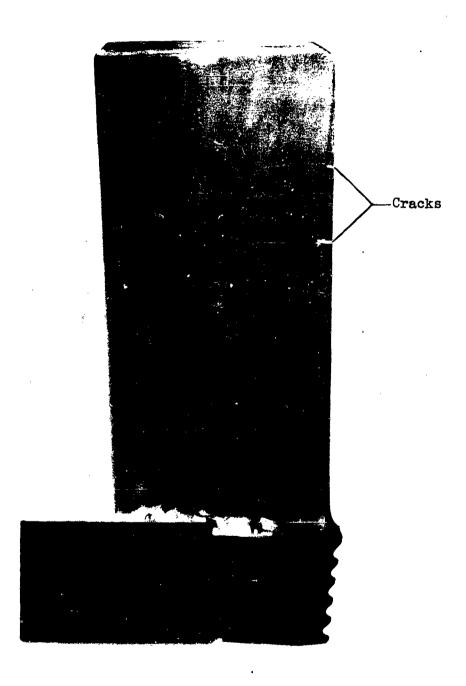
C-39786

Figure 3. - HS-21 spray-cooled turbine blade with cracks in trailing edges after nine cycles of operation with sudden water injection.

Figure 3 shows an HS-21 blade after 9 cycles. The trailing-edge cracks illustrated in this figure are typical of all those encountered. The fifth blade material, Guy alloy, failed immediately upon introduction of the water during the first cycle. Figure 4 shows the root section of a failed Guy alloy blade. Failure occurred at the blade root section in both Guy alloy test blades. The generally brittle nature of the material probably played a major role in this result. X-ray examination of these Guy alloy blades prior to operation indicated casting imperfections in one blade that may also have contributed to the blade failures.

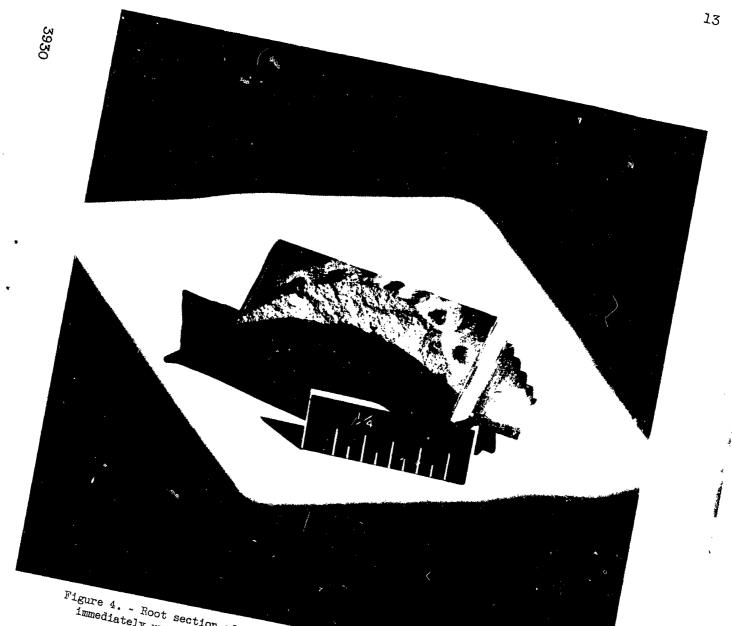
Figure 4. Root section of Guy alloy spray-cooled turbine blade that failed

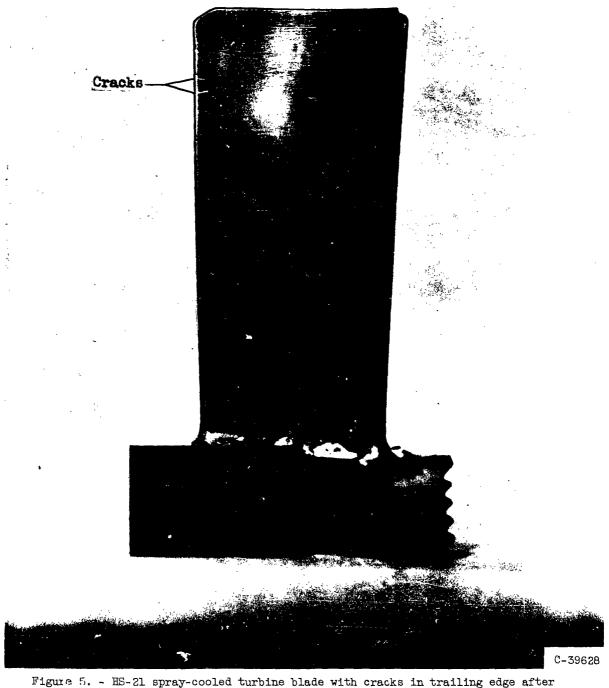
Figure 5. - HS-21 spray-cooled turbine blade with cracks in trailing edge after 10 cycles of operation with gradual water injection.

Tests with gradual water injection. - Two of the blade materials, HS-21 and Inconel X, were investigated under conditions of gradual water injection as a means of reducing the thermal-shock effect. The test blades of these materials had cracks similar to (and in one case even more pronounced than) cracks in the blades investigated under conditions of sudden water injection. Figure 5 shows an HS-21 blade after 10 cycles with gradual water injection. The cracks occurred at about the same spanwise position as on one of the HS-21 blades tested with sudden water injection. The Inconel X blades both showed a pronounced crack at the leading edge as well as smaller cracks at the trailing edge after 10 cycles. Figure 6 shows one of the Inconel X blades after 10 cycles utilizing gradual water injection. A large crack at the leading edge, approximately at the 2/3-span position is clearly visible. A similar crack was observed on the other Inconel X test blade. Slight trailing-edge cracks were observed but are not apparent in this figure. Comparison of these results with those for sudden water injection indicates that no improvement in blade life resulted for HS-21 and Inconel X blades, and further tests with gradual water injection were abandoned.

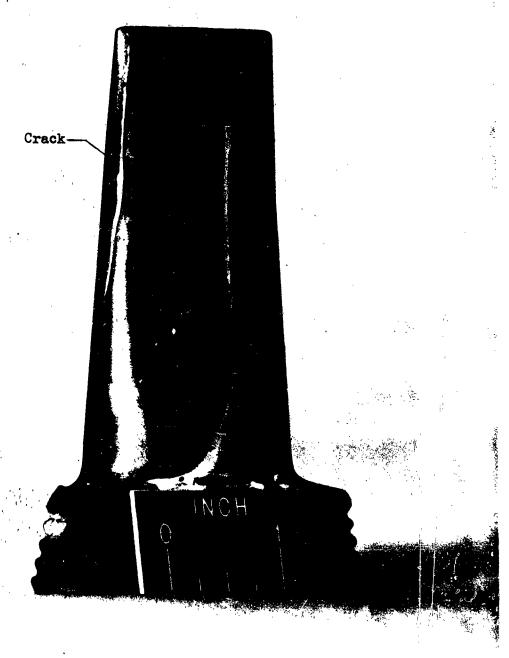
C-39596

Figure 6. - Inconel X spray-cooled blade with crack in leading edge after 10 cycles of operation with gradual water injection.
